SUBJECT Willow Creek Access Site Evaluation

SONOMA COAST STATE BEACH GENERAL PLAN
WILLOW CREEK ACCESS POINTS
SITE ANALYSIS

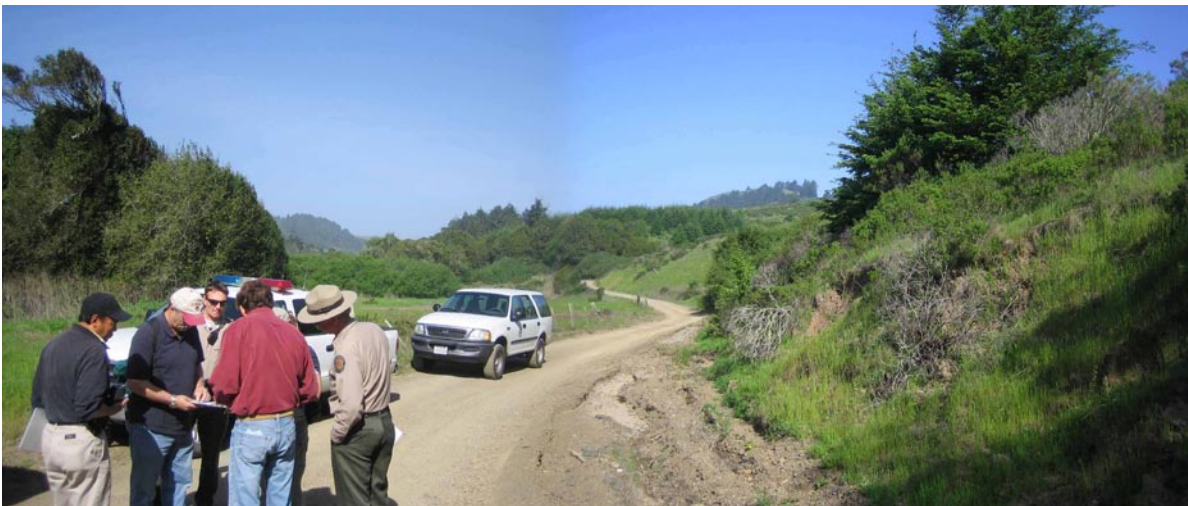
Site A - looking west - eroded roadway swale on left.

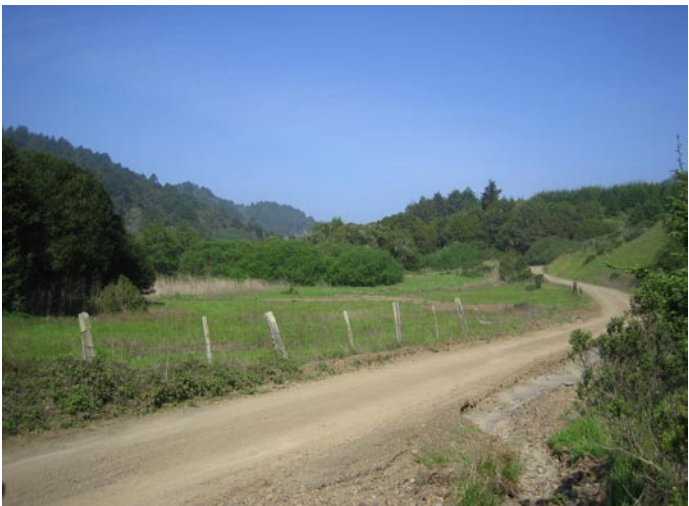
Site A - looking west - eroded roadway swale on left.

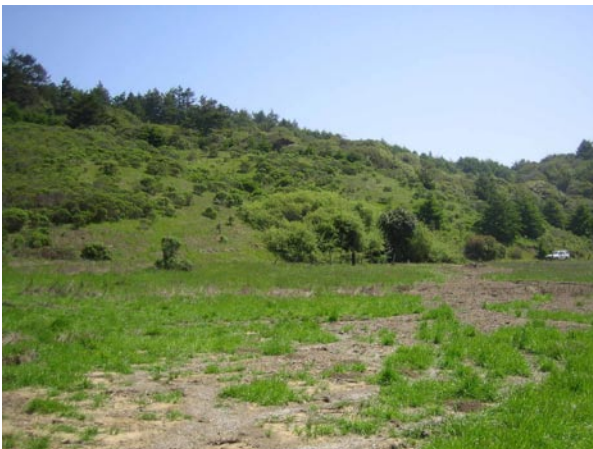
Site A - looking northeast - eroded area/soil deposits in center of photo.

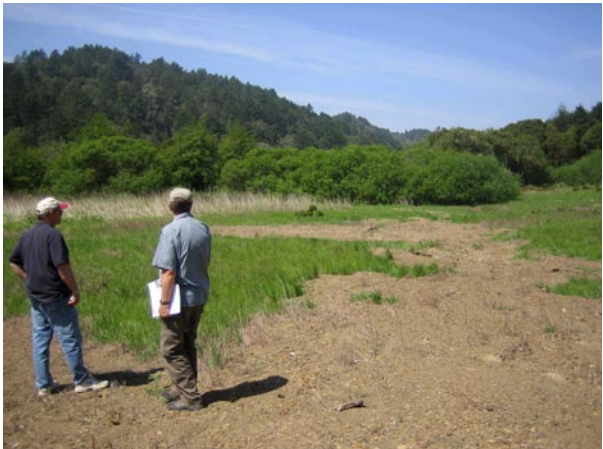
Site A - looking southwest at eroded area.

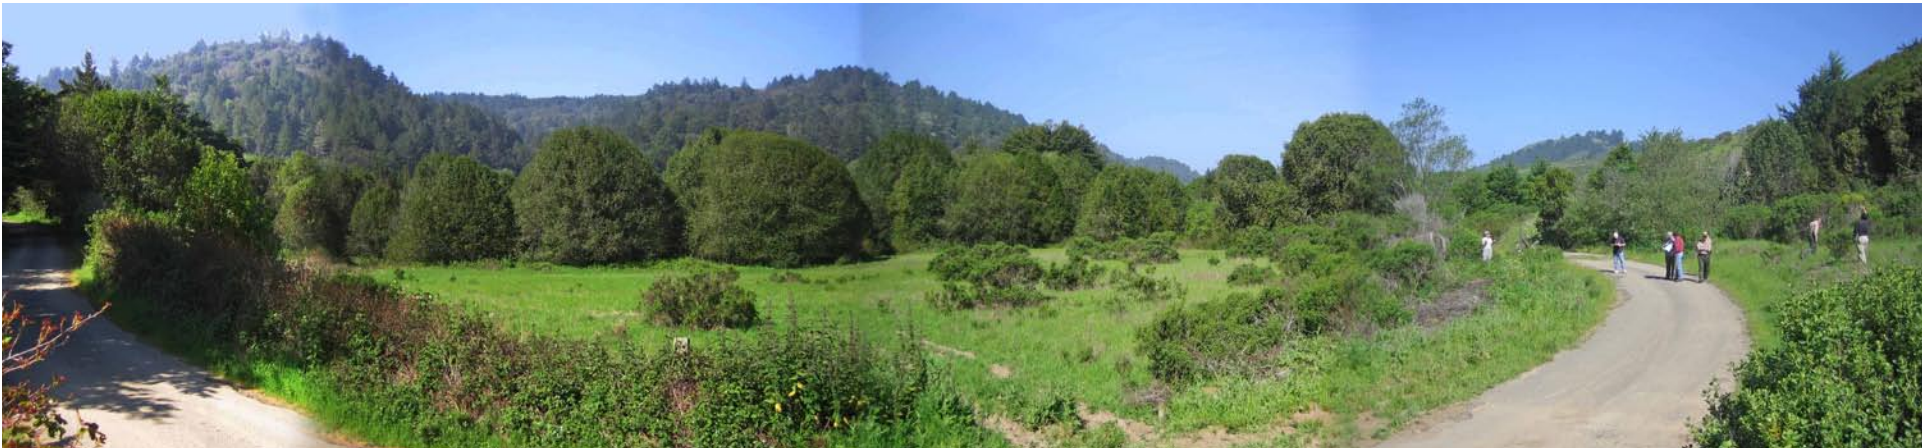
Site B - looking south - potential day-use bench on far right.

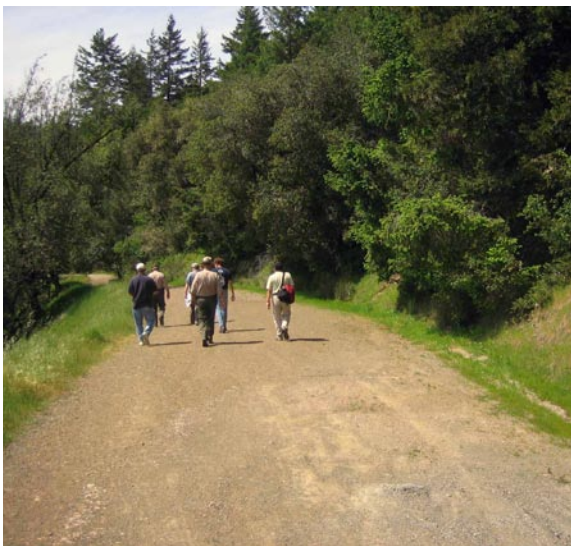
Access road below road wash-out.

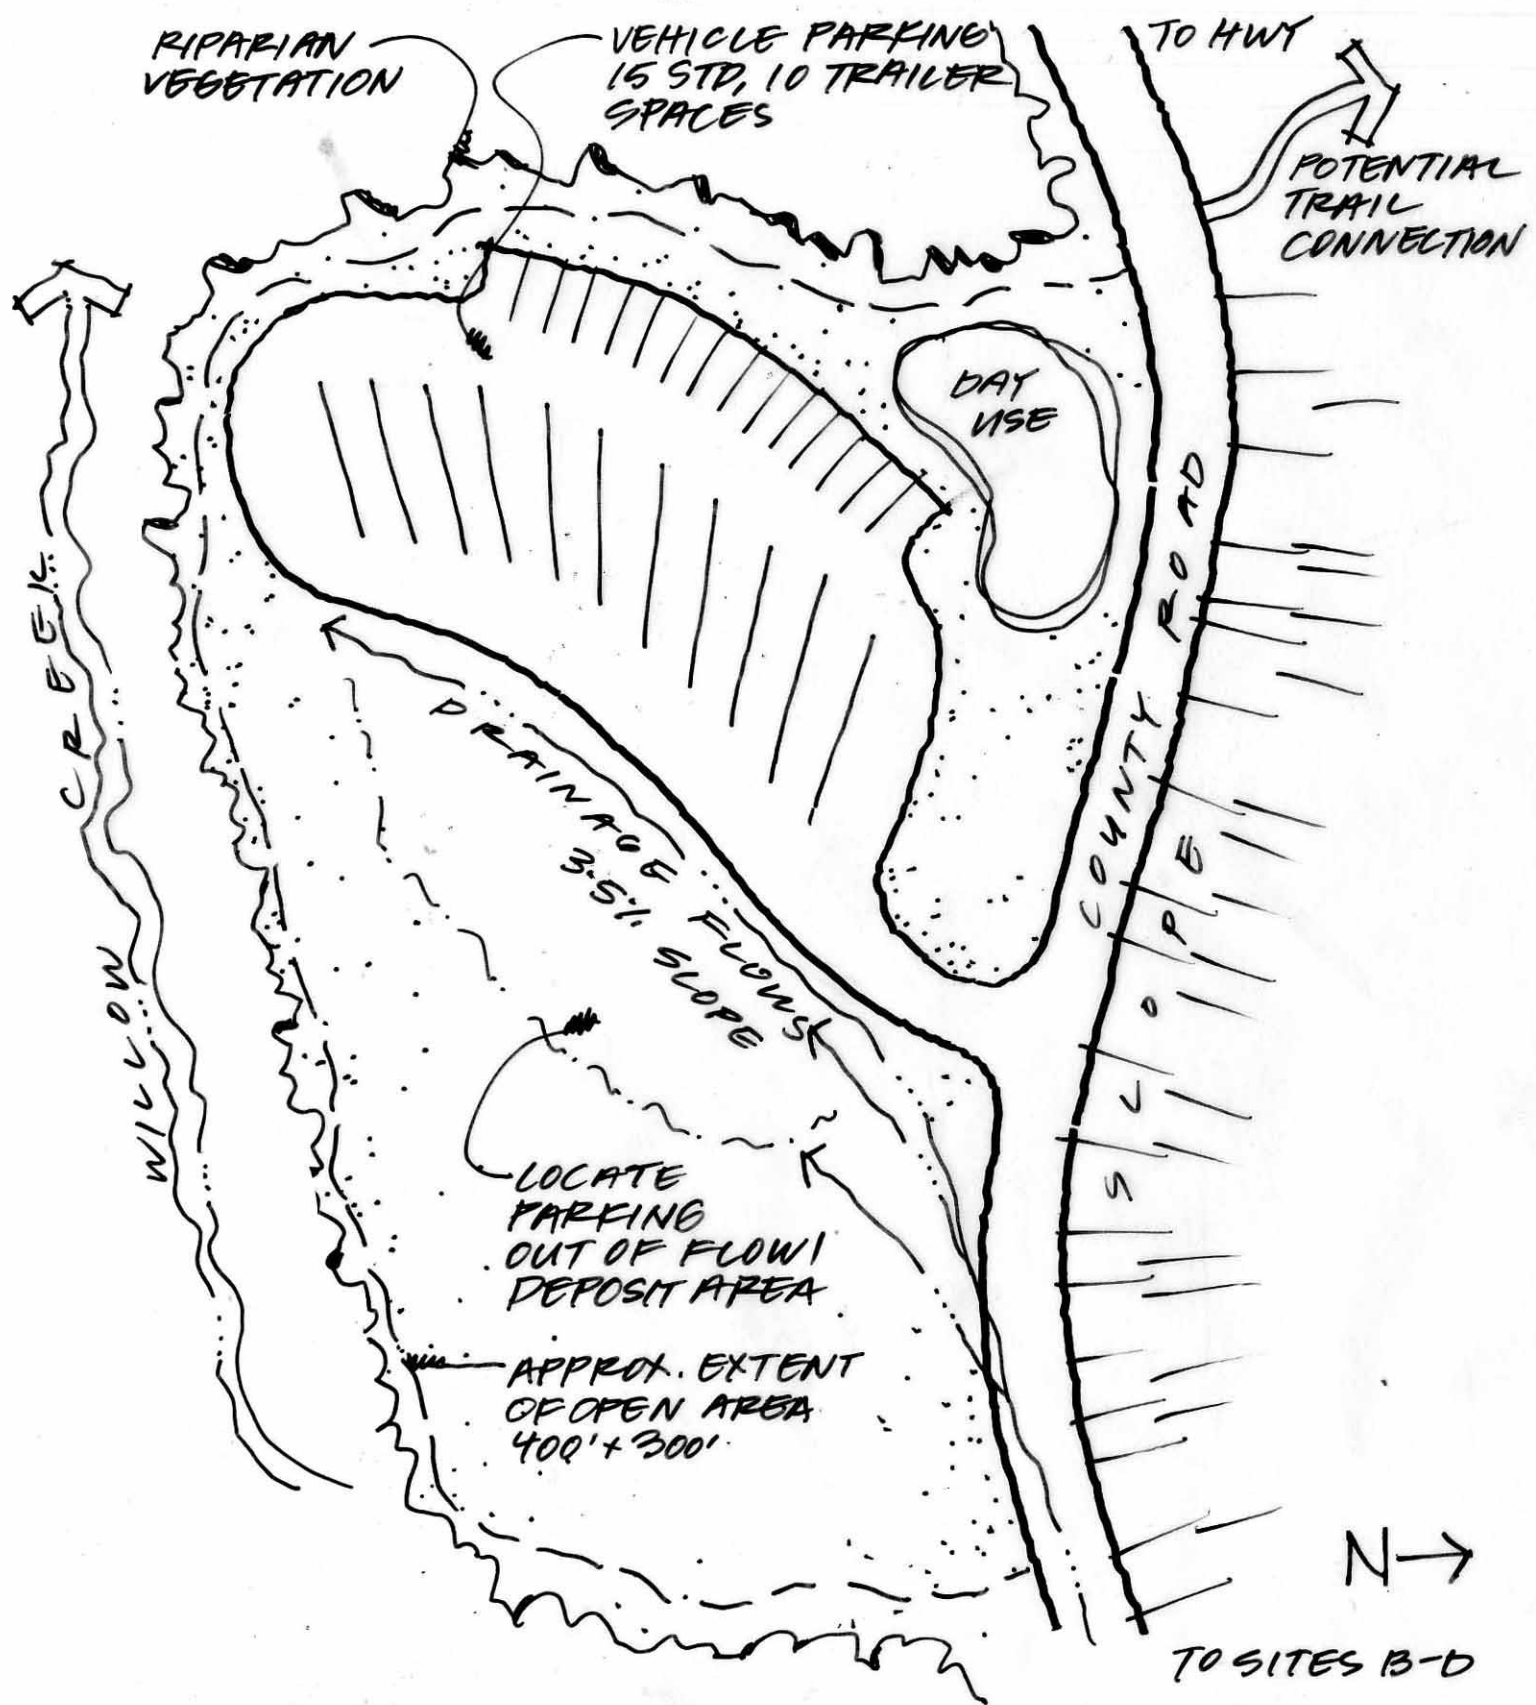
Figure 1.0
Lower Willow Creek Site A

- South side of the Willow Creek Road.
- Willow Creek and significant riparian vegetation adjacent to the southern edge of the site.
- Site slopes toward the Creek at approximately 2-5% grade.
- Open area approximately 500' x 300' from roadway to Creek at its maximum width. Open area has been significantly disturbed by erosion and flood flows originating on the roadway at the eastern edge of the site.

- Willow Creek Road would serve as the trail for access into upper reaches of the park. Users will have to pass on-foot through the private ranch site on the road, creating potential conflicts. A trail connecting this site past the ranch would help alleviate potential conflicts.
- Development setbacks from the riparian area may be needed to protect the Creek corridor.
- Upstream drainage improvements would be necessary to maintain any facilities on this site without continued significant erosion.
- Use of Best Management Practices (BMP's) for stormwater run-off would be recommended at this site to maintain water quality within the Creek.
- Views into the site from other areas of the Park are minimal.

- This site is well suited for a larger, primary access. Equestrian trailer parking could be accommodated in this area, as well as additional vehicle parking. Site is geographically centrally located.
- Other day use, such as picnicking could also be accommodated at this site.
- Potential exists for trail connections into the park from this area through the conservation easement.

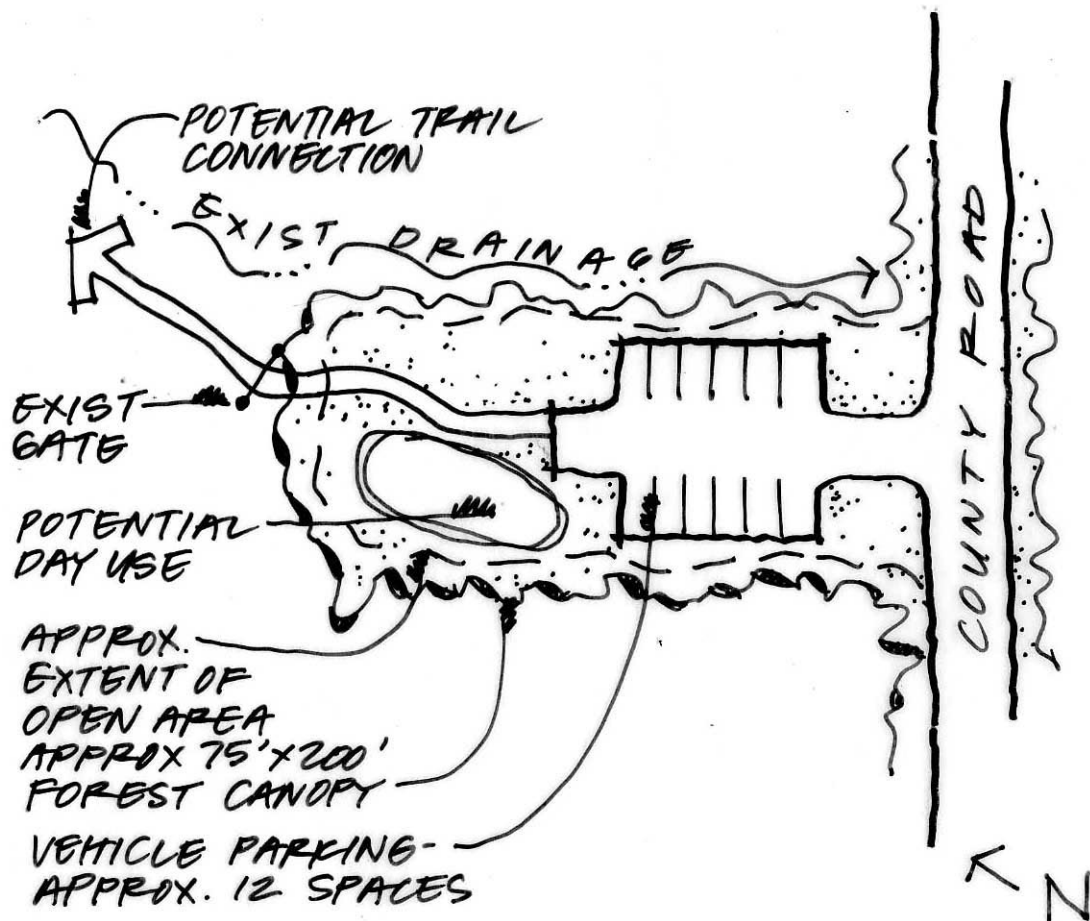
Figure 3.0
Lower Willow Creek Site C

- North side of the Willow Creek Road.
- Open area approximately 75' x 200'.
- Site is within the forest canopy and has mature trees surrounding the open area.
- Site slopes toward the road at approximately 2-5% grade.

- Site C could be used for vehicle only parking, with a small amount of equestrian parking occurring at Site D.
- Hazard trees may be a problem at this site.
- This site potentially contains Spotted Owl habitat. Surveying may be needed prior to any improvements.

- This is the smallest of the Lower Willow Creek sites and is well suited for a smaller, secondary access. Equestrian trailer parking could not be accommodated in this area, due to the small size of the open area and lack of turn-around space.
- A small picnic site could also be accommodated at this location.
- The site is much further into the Park than sites A or B, allowing quicker access into the upper reaches of Willow Creek.

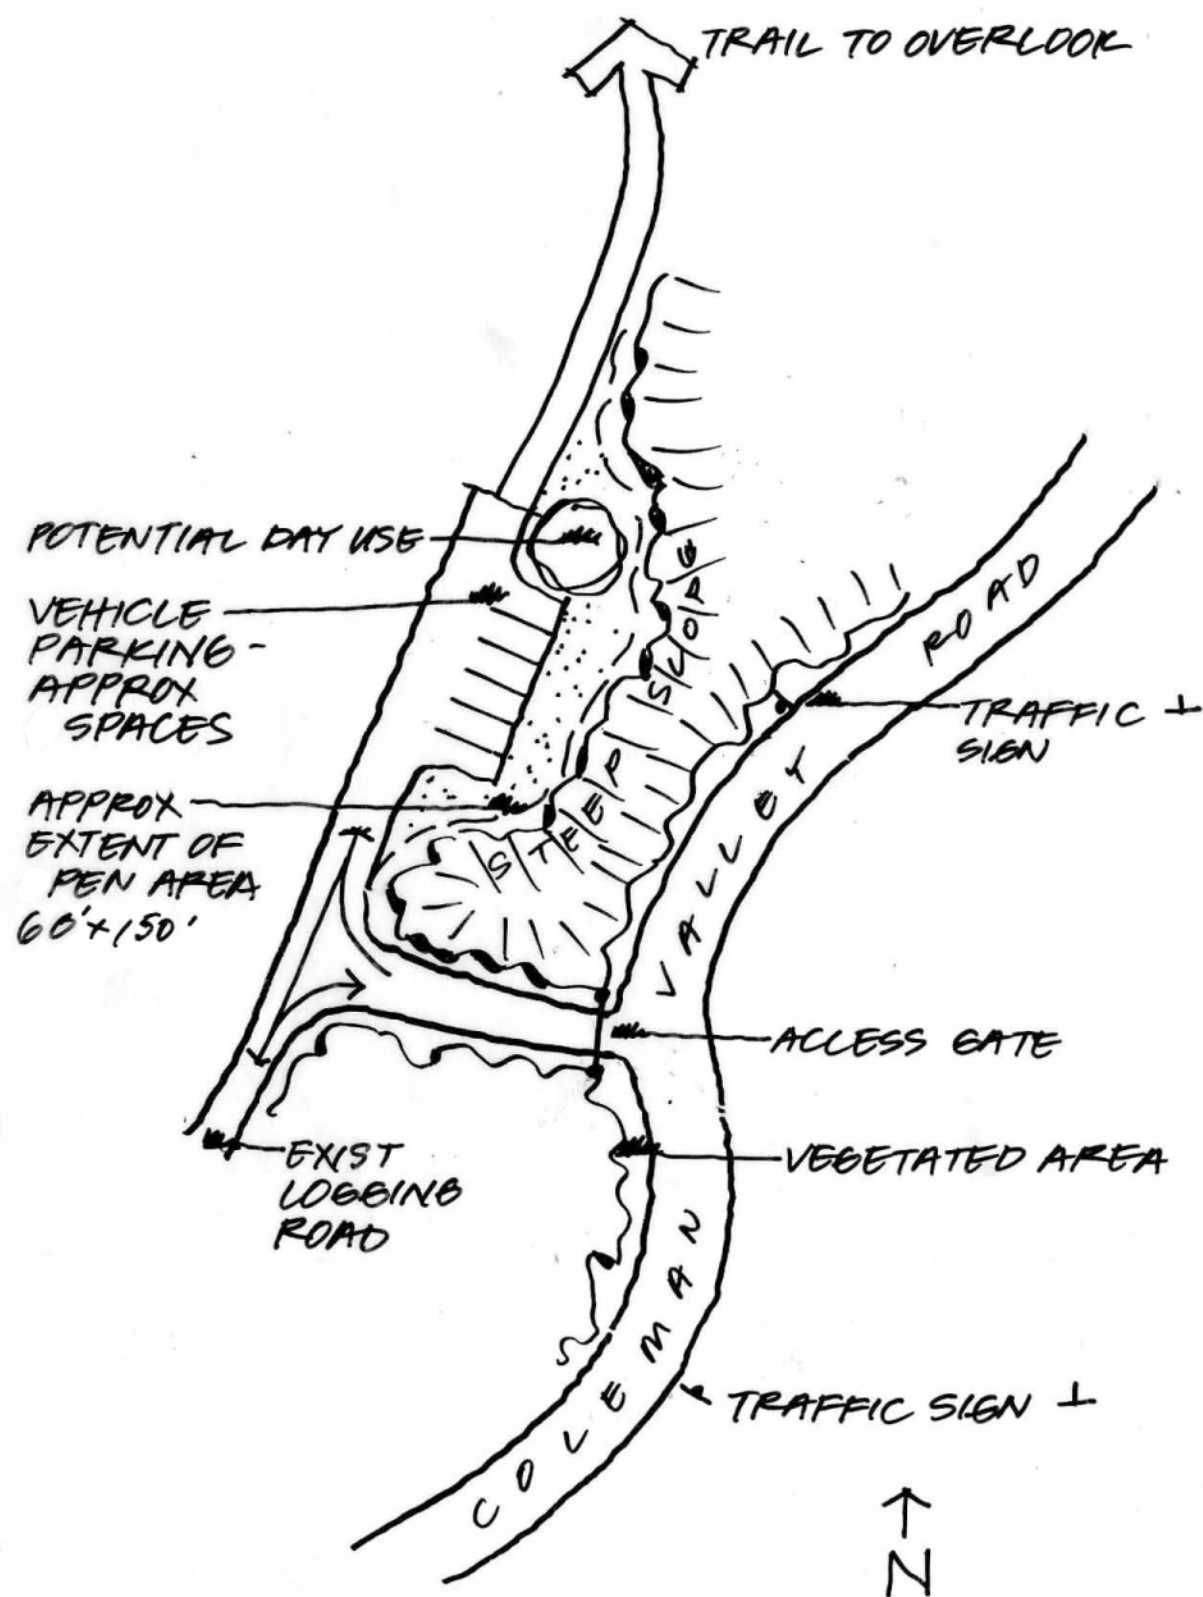
Figure 8.0
Coleman Valley Road

- North side of Coleman Valley Road in the southeast portion of the site.
- Open area approximately 60' x 150'.
- Site is within the forest canopy and has mature trees surrounding the open area.
- Road gradients are approximately 2-5% grade, general slope characteristics of the area are in the above 10% category.
- Located on existing road alignment and access on Coleman Valley Road.

- Road access point is along a hill and curve, making visibility in and out of the access difficult. Roadway signage may be necessary to mitigate potential traffic conflicts. Visibility of cars leaving the trailhead is most problematic to the south, where Coleman Valley Road slopes steeply downhill.

- Hazard trees may be a problem at this site.
- Area would require some grading and earth moving to accommodate reasonable parking and maneuvering space for 6 to 8 vehicle capacity.

- The remote location of this site makes it well suited as a secondary access.
- The site will accommodate approximately 6 vehicles.
- The site has several options for providing small picnic areas.
- A trail connecting the access point to a viewpoint overlook is easily possible along the existing road alignment. With a few modifications, the trail could be made to meet accessibility requirements.

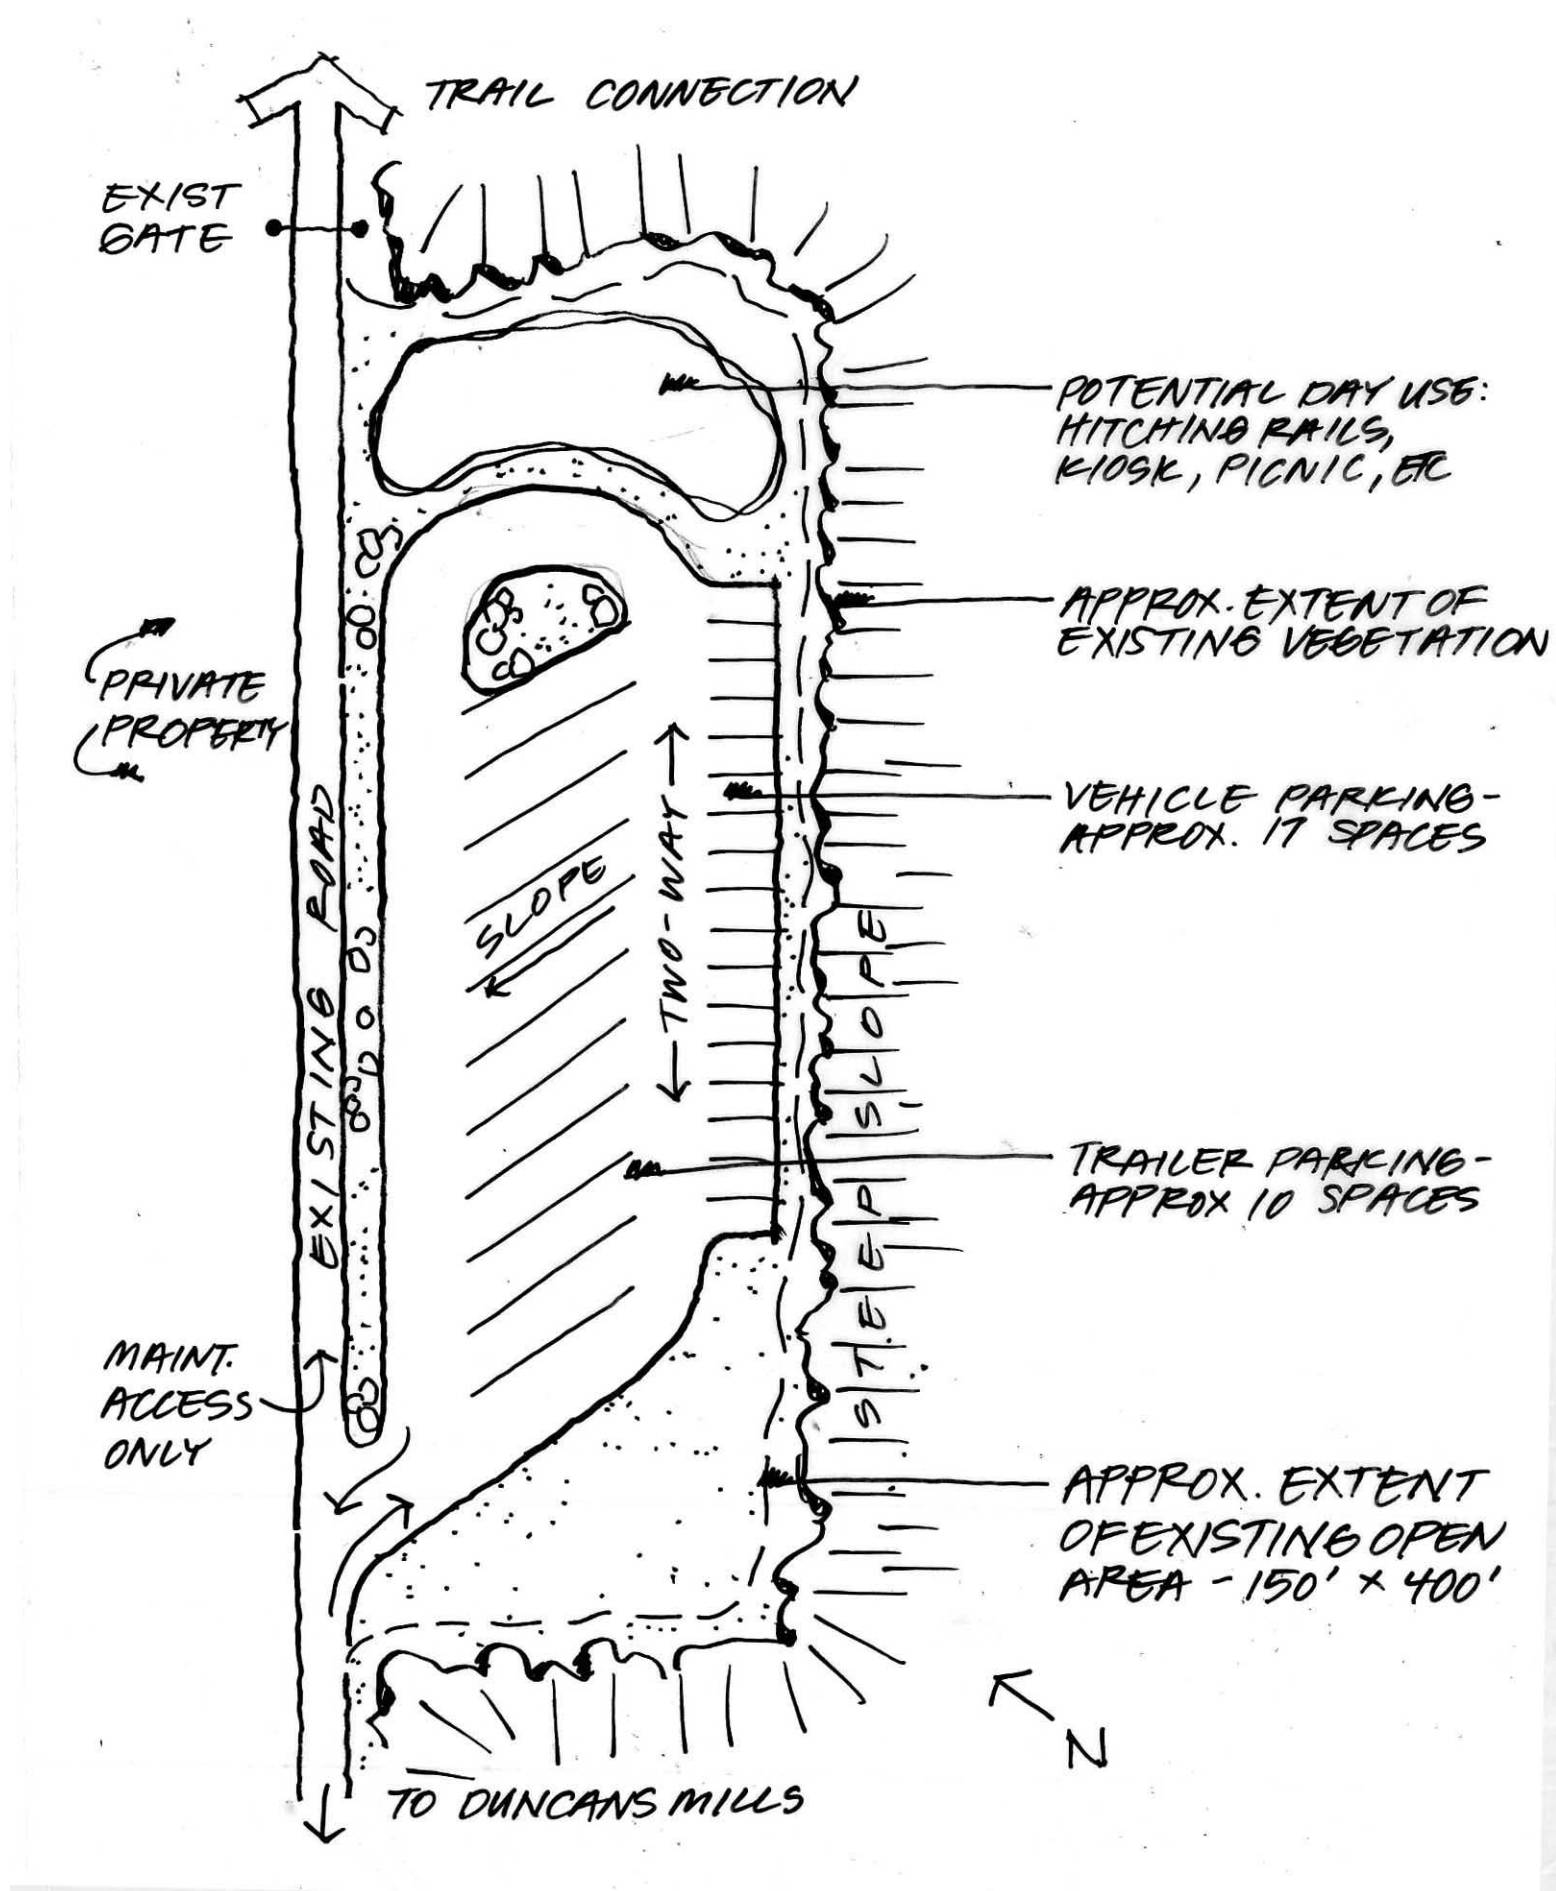
Figure 9.0
Freezeout Flat

- North side of Freezeout Flat Road in the northwest portion of the site.
- Open area approximately 150' x 400'.
- Site is located adjacent to an open meadow, at the base of a hillside to the south.
- Sight lines into and out of the site are good.
- Site slopes at approximately 2-5% grade.
- An existing trail, with gate and signage begins at the east end of the access site and continues up Freezeout Creek.
- Views into the site from other areas in the Park are minimal.

- The Freezeout Flat road coming into the site is a long, narrow, one-way which may present difficulties for passing vehicles, especially those with trailers. Adding pull-outs at several points along the roadway may help alleviate this problem.
- The site is adjacent to the meadow used for civil war reenactments. The existing parking area is currently used during these events, creating a potential impact/conflict with Park users.
- Drainage adjacent to the road will need to be addressed and may require the installation of culverts or other conveyances.
- There are private property inholdings that use this access.

- This site is already used as a trailhead for approximately 5-6 equestrian/trailer spaces.
- This site's close proximity to Duncan's Mills makes it an ideal candidate as a primary trailhead including an equestrian access for the Willow Creek parcel.
- The site is large enough to provide turn-around space for truck-trailer combinations, vehicle parking and day use areas.
- The addition of equestrian amenities such as manure collection, hitching posts and corrals may be possible at this site.
